Kinetix 6500 Modular Multi-axis Servo Drives, Firmware Revisions 2.001...2.018

Catalog Numbers 2094-EN02D-M01-S0, 2094-EN02D-M01-S1

About This Publication

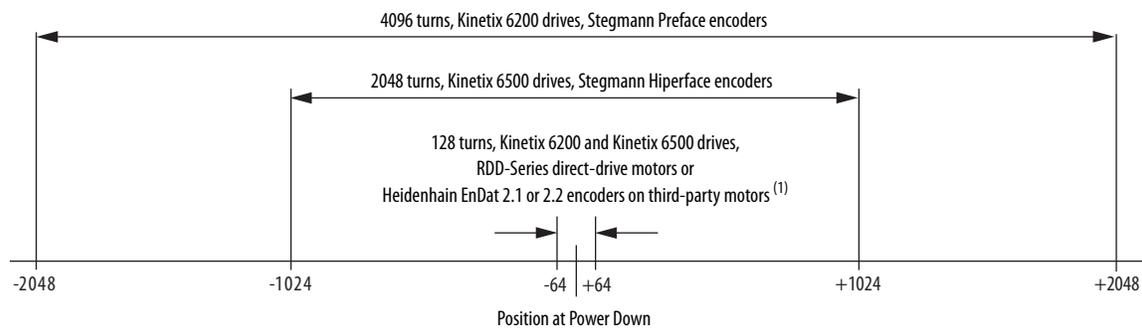
Figure 1 - Absolute Position Retention Limits

(1) Absolute position retention limit (± 64) for Heidenhain EnDat 2.2 is the worst case.

(1) Refer to [Figure 1](#) and [Table 2](#) for additional information about these encoder types.
